# Reducing Utility Damages -Case Studies-

**Stephen Thomas**  
**Damage Prevention Specialist**  
**Division of Utility and Railroad Safety**  
**State Corporation Commission**

# Case Studies

# **Route 3 Widening Spotsylvania County**

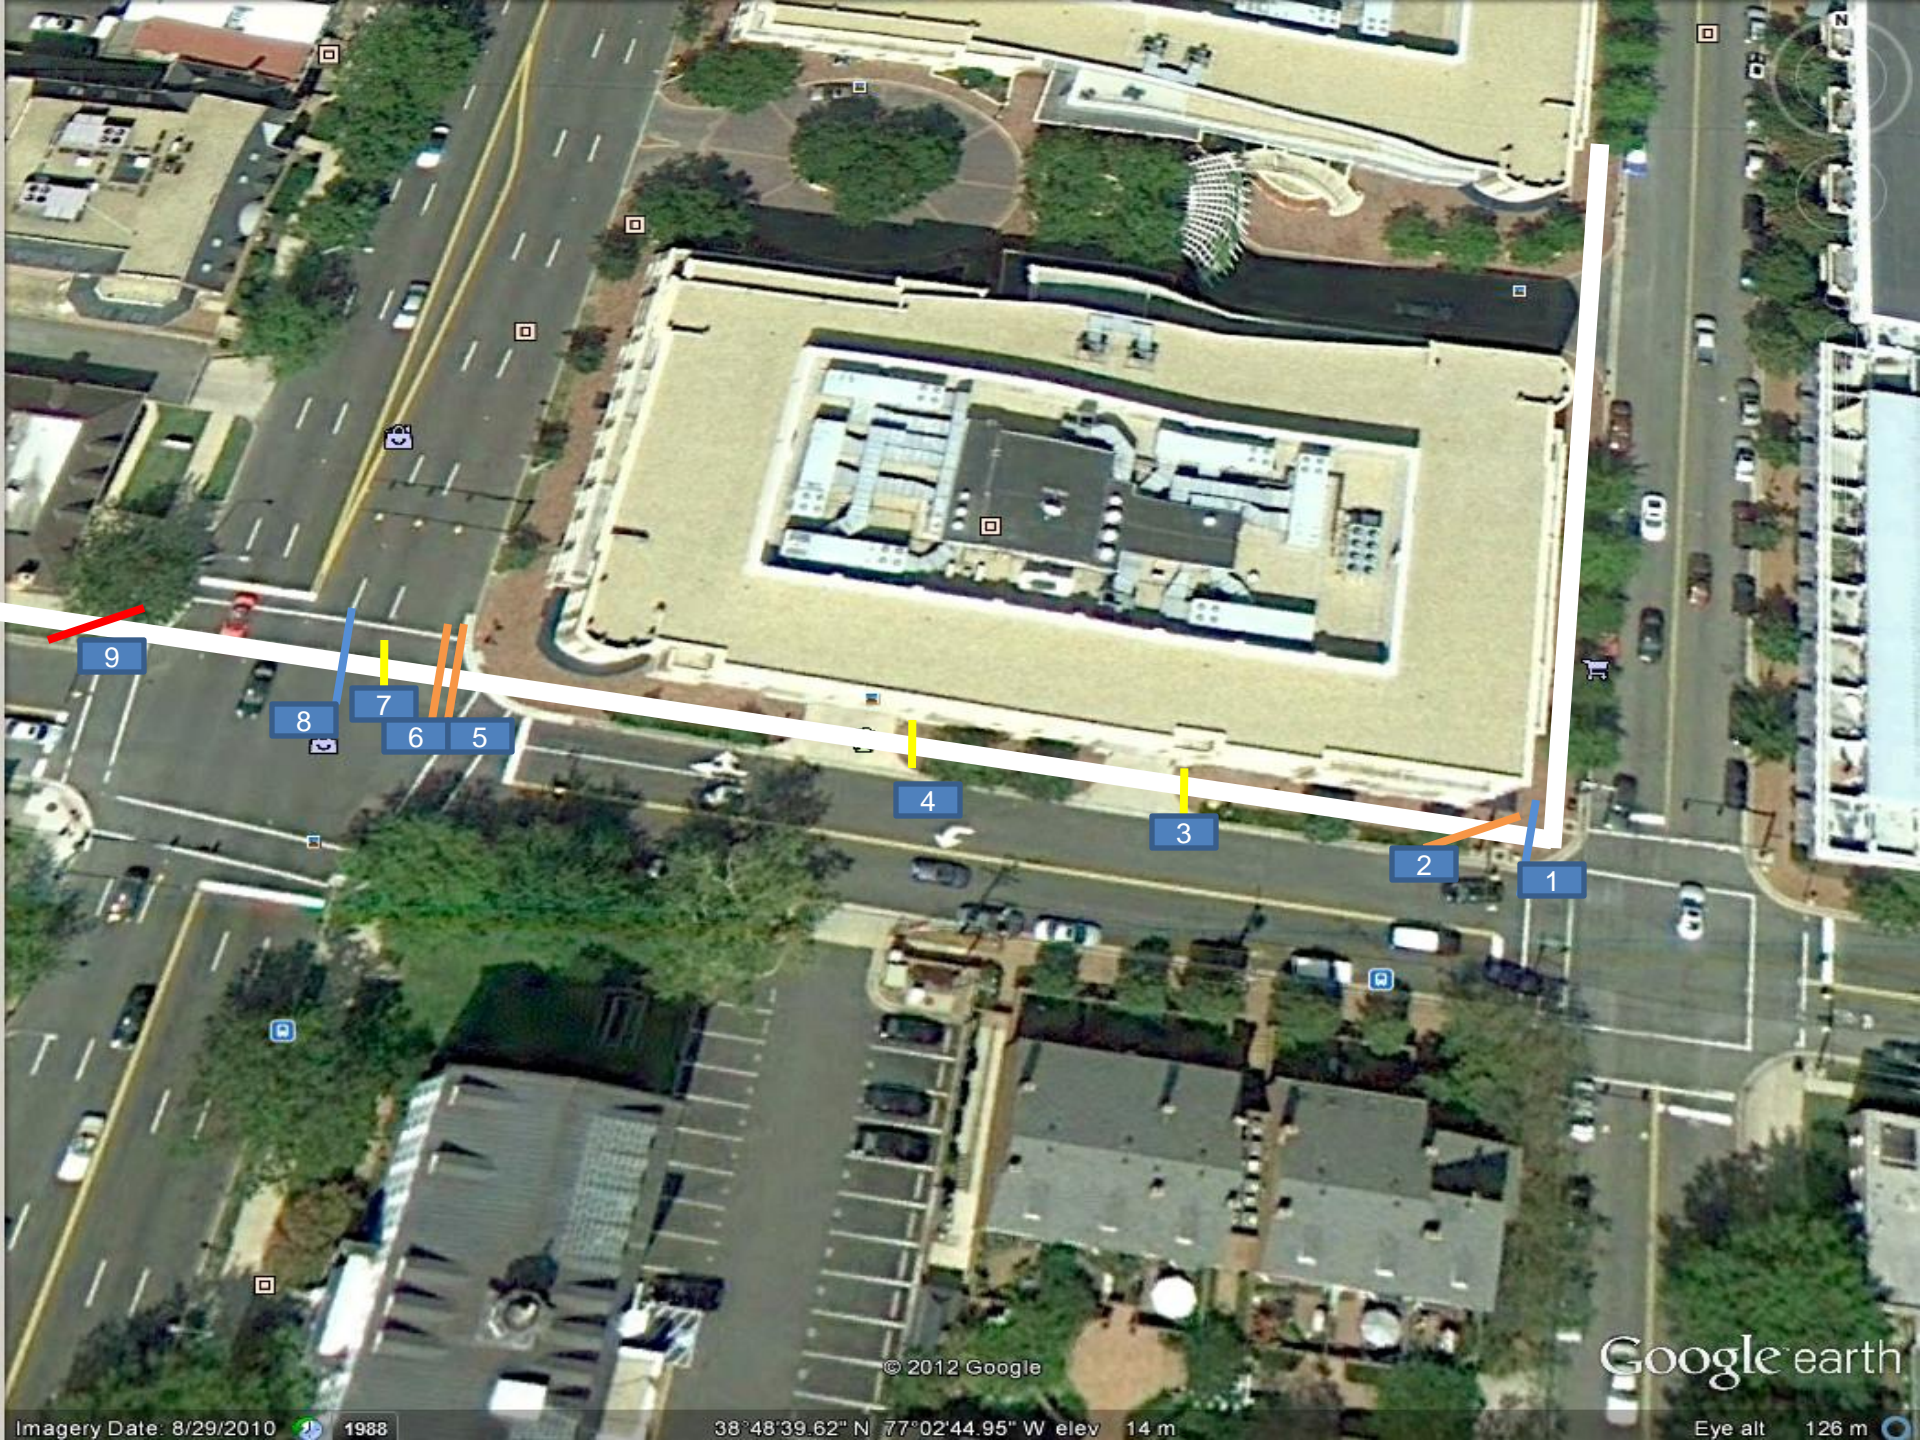
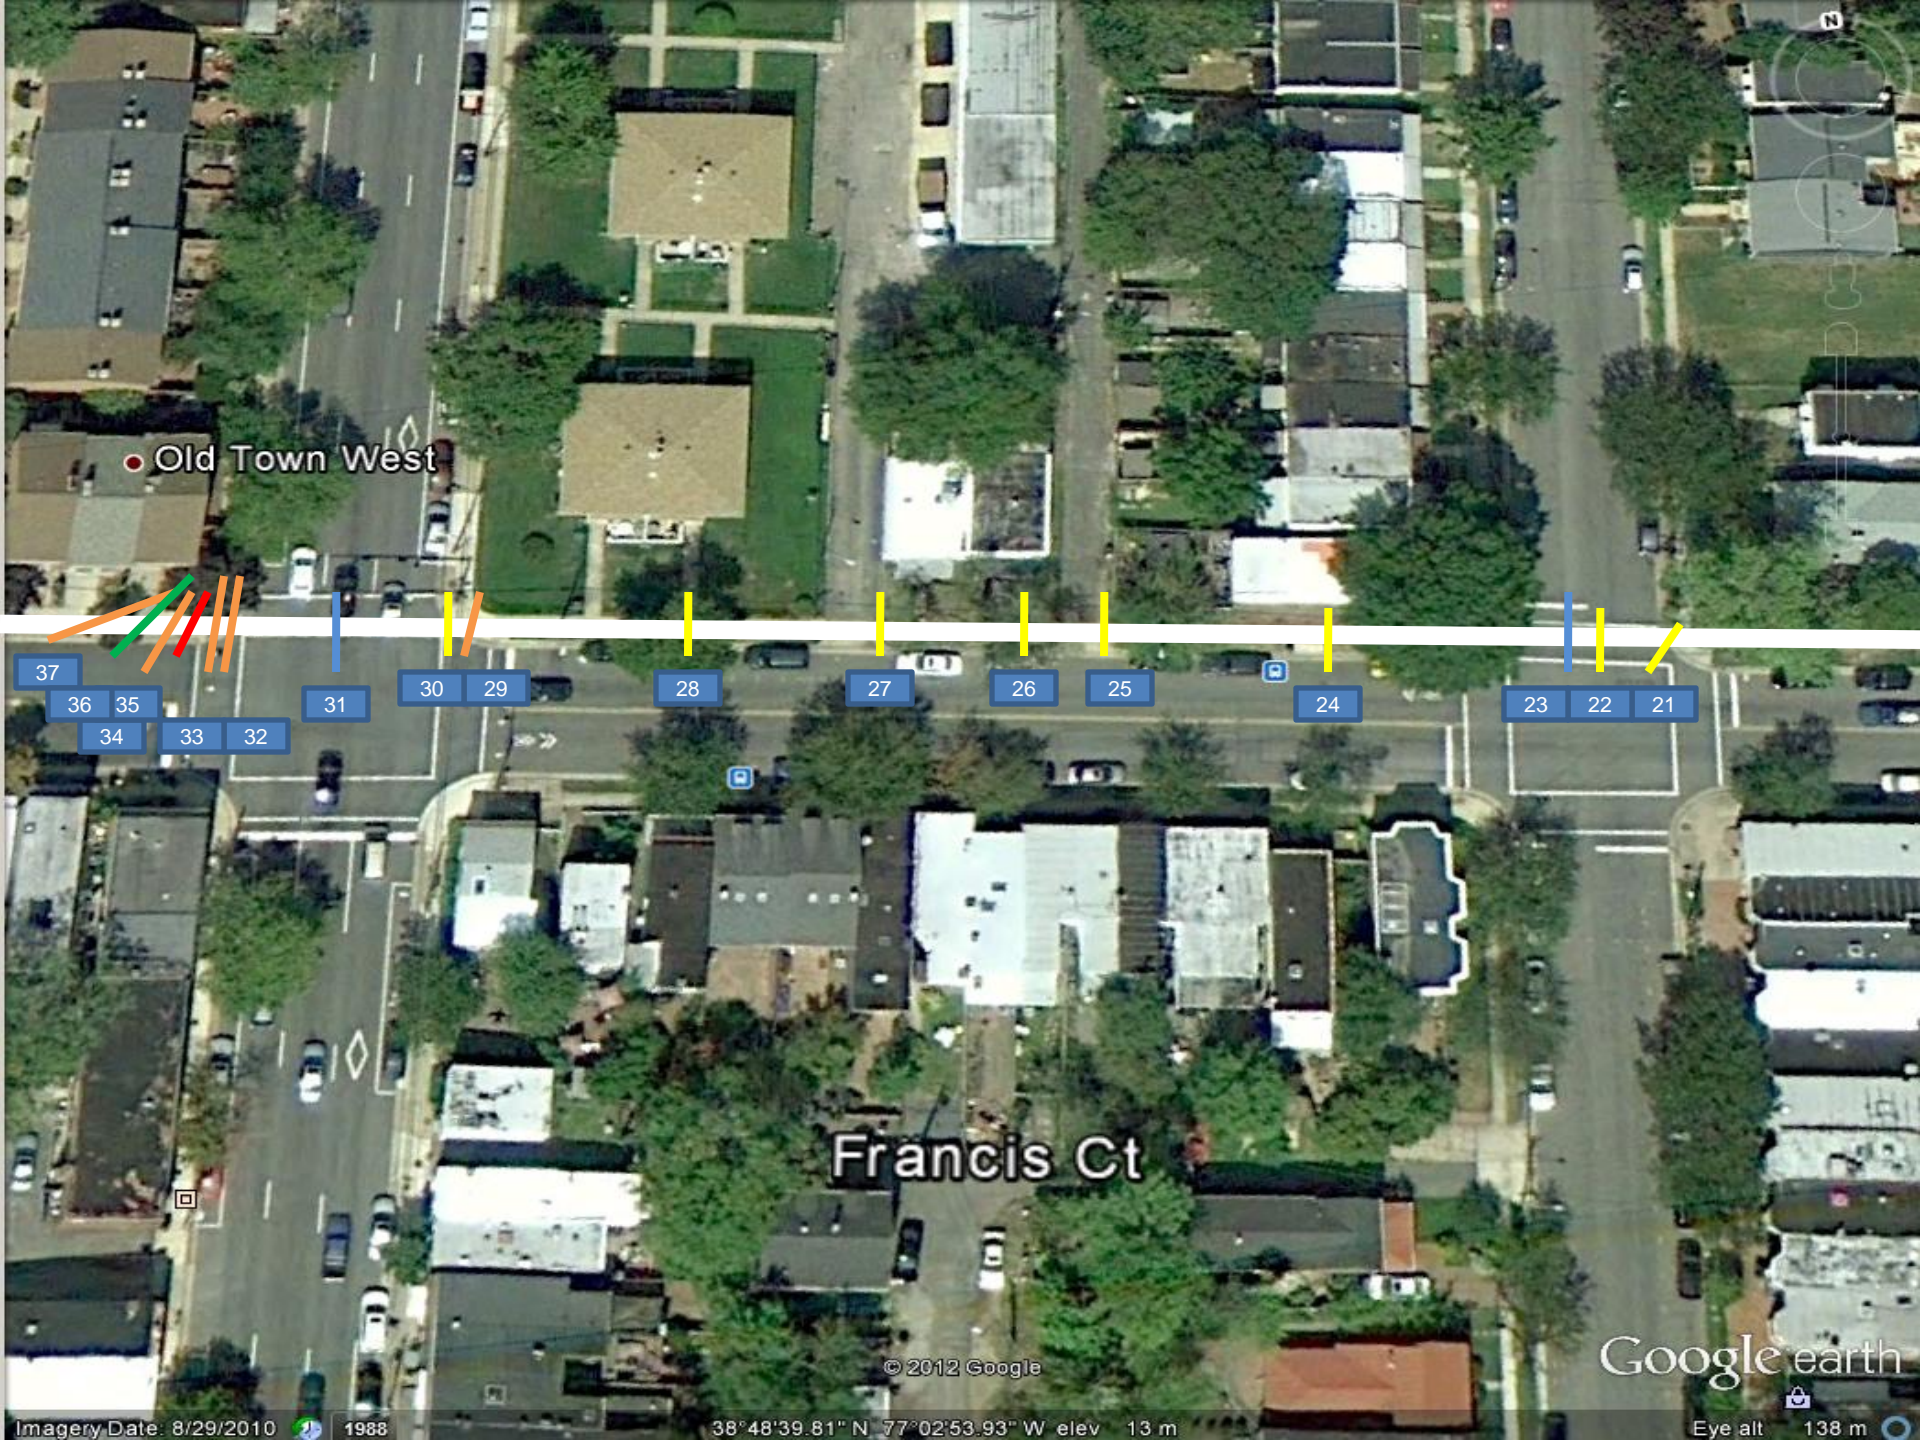
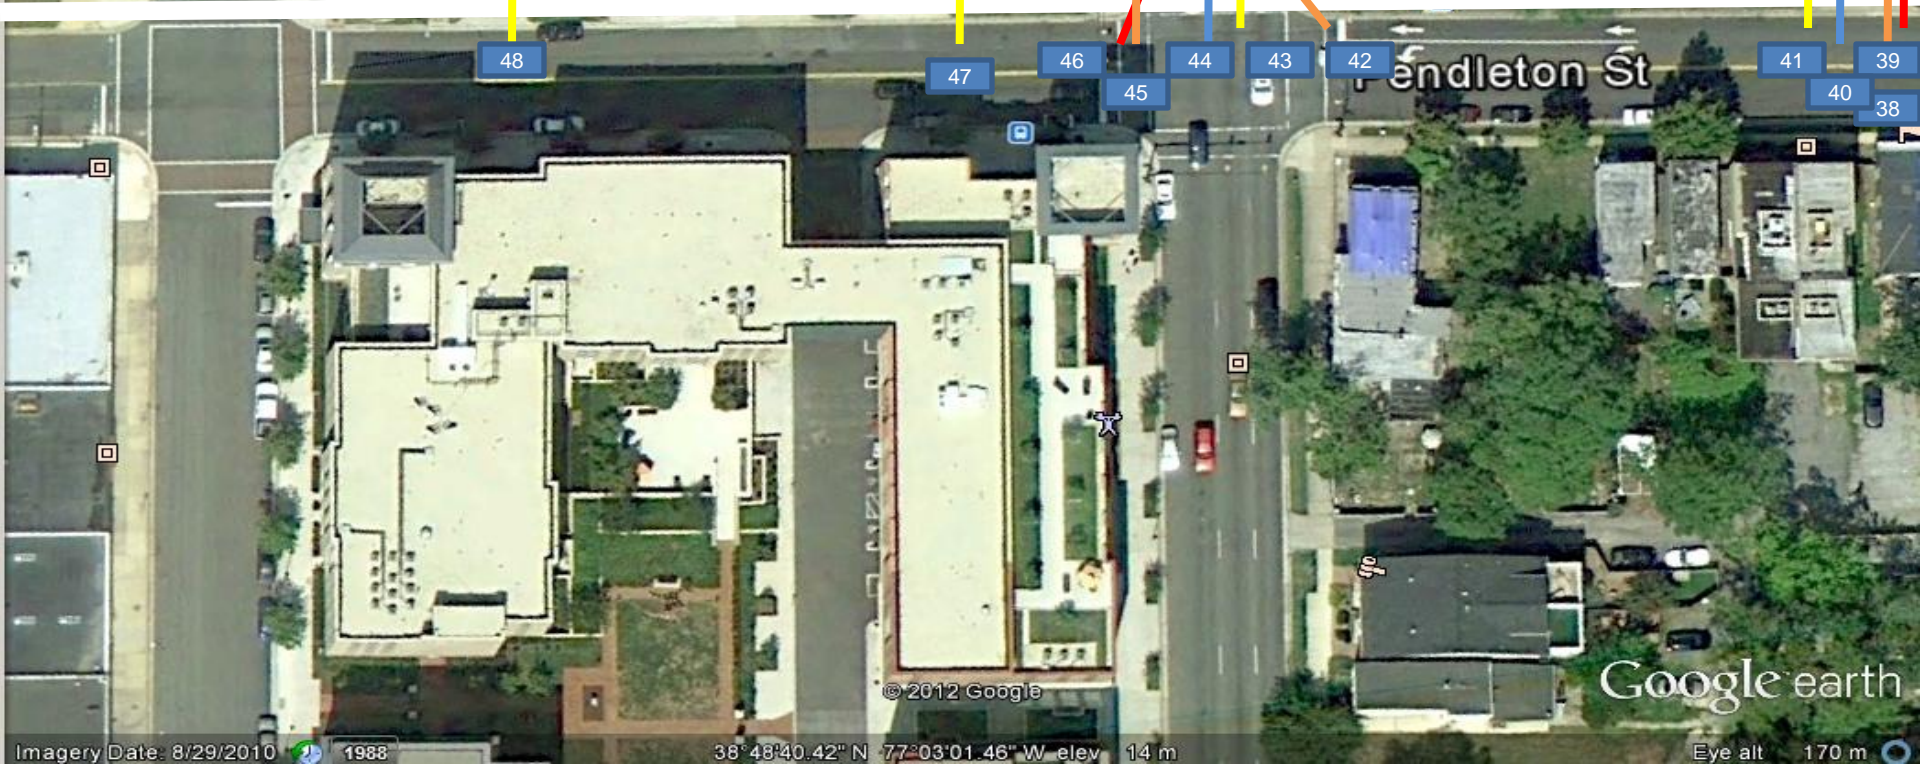
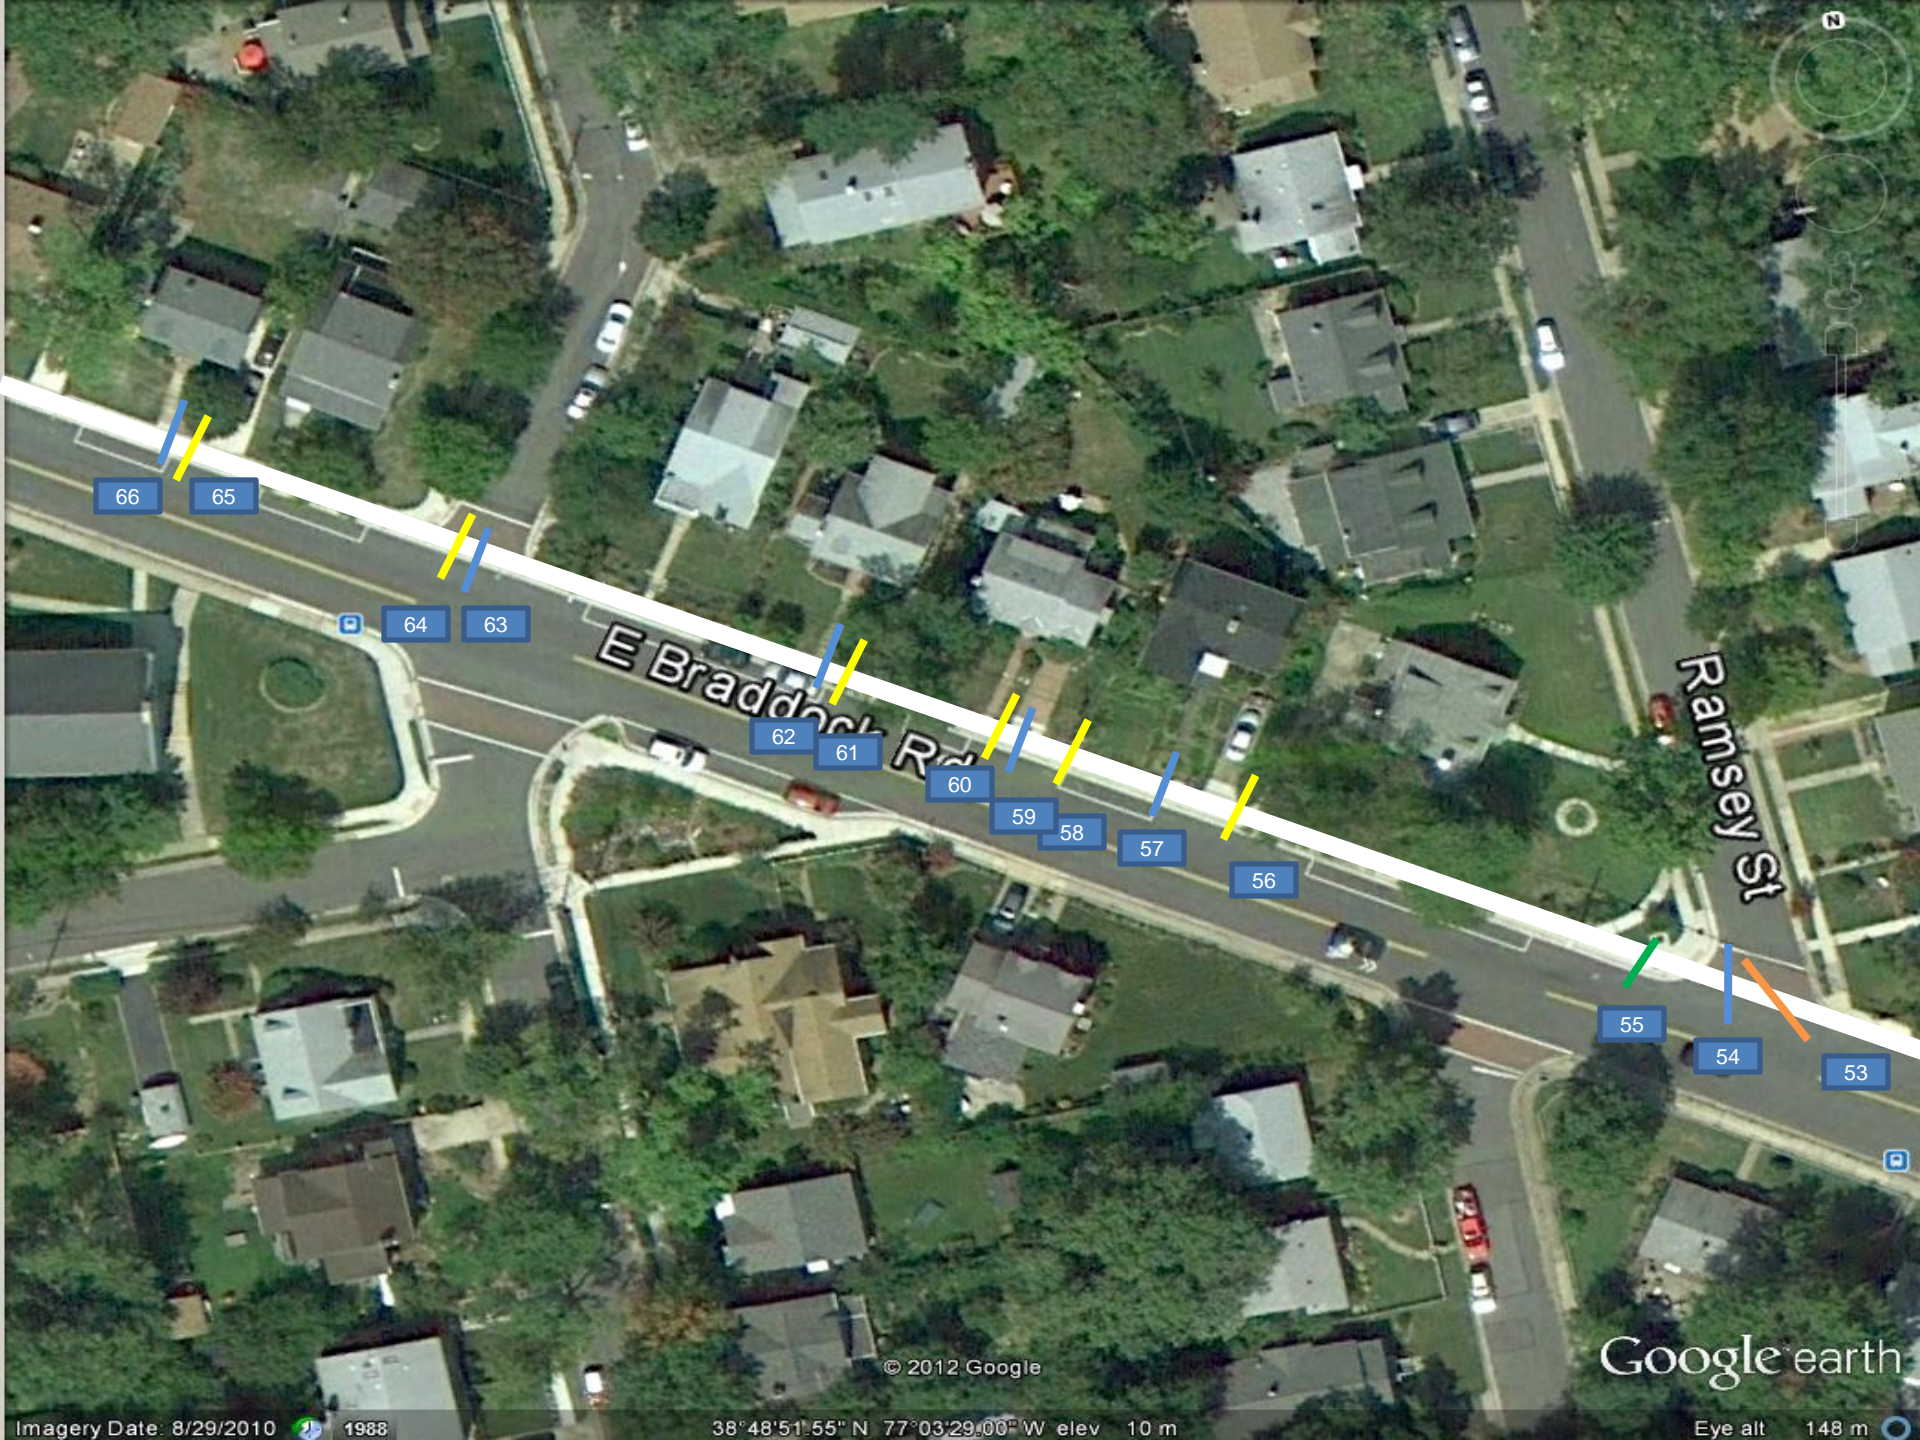
- Total of 111 utilities not potholed:
  - 109 utilities crossed without potholing
    - 18 communication
    - 27 water
    - 9 power
    - 8 sewer
    - 47 gas
  - 1 communication utility paralleled without exposing at reasonable distances
  - 1 gas utility that the bore path came within 2 feet and it was not potholed

- Probable Violations:
  1. 111 – 24A (Exercise due care to protect the utility)
  2. 111 – 150.6 (Pothole while crossing or paralleling)
  3. 110 – 150.8 (Watch drill head pass through potholes)
  4. 110 – 150.4 (Ensure sufficient clearance during pullback)
- Civil Penalty - \$97,750.00
- Remedial Actions:
  1. Company will expose all utilities crossed that were not potholed to ensure no damage has occurred and proper separation is achieved
  2. Company will be required to take mandatory training without a reduction in penalty

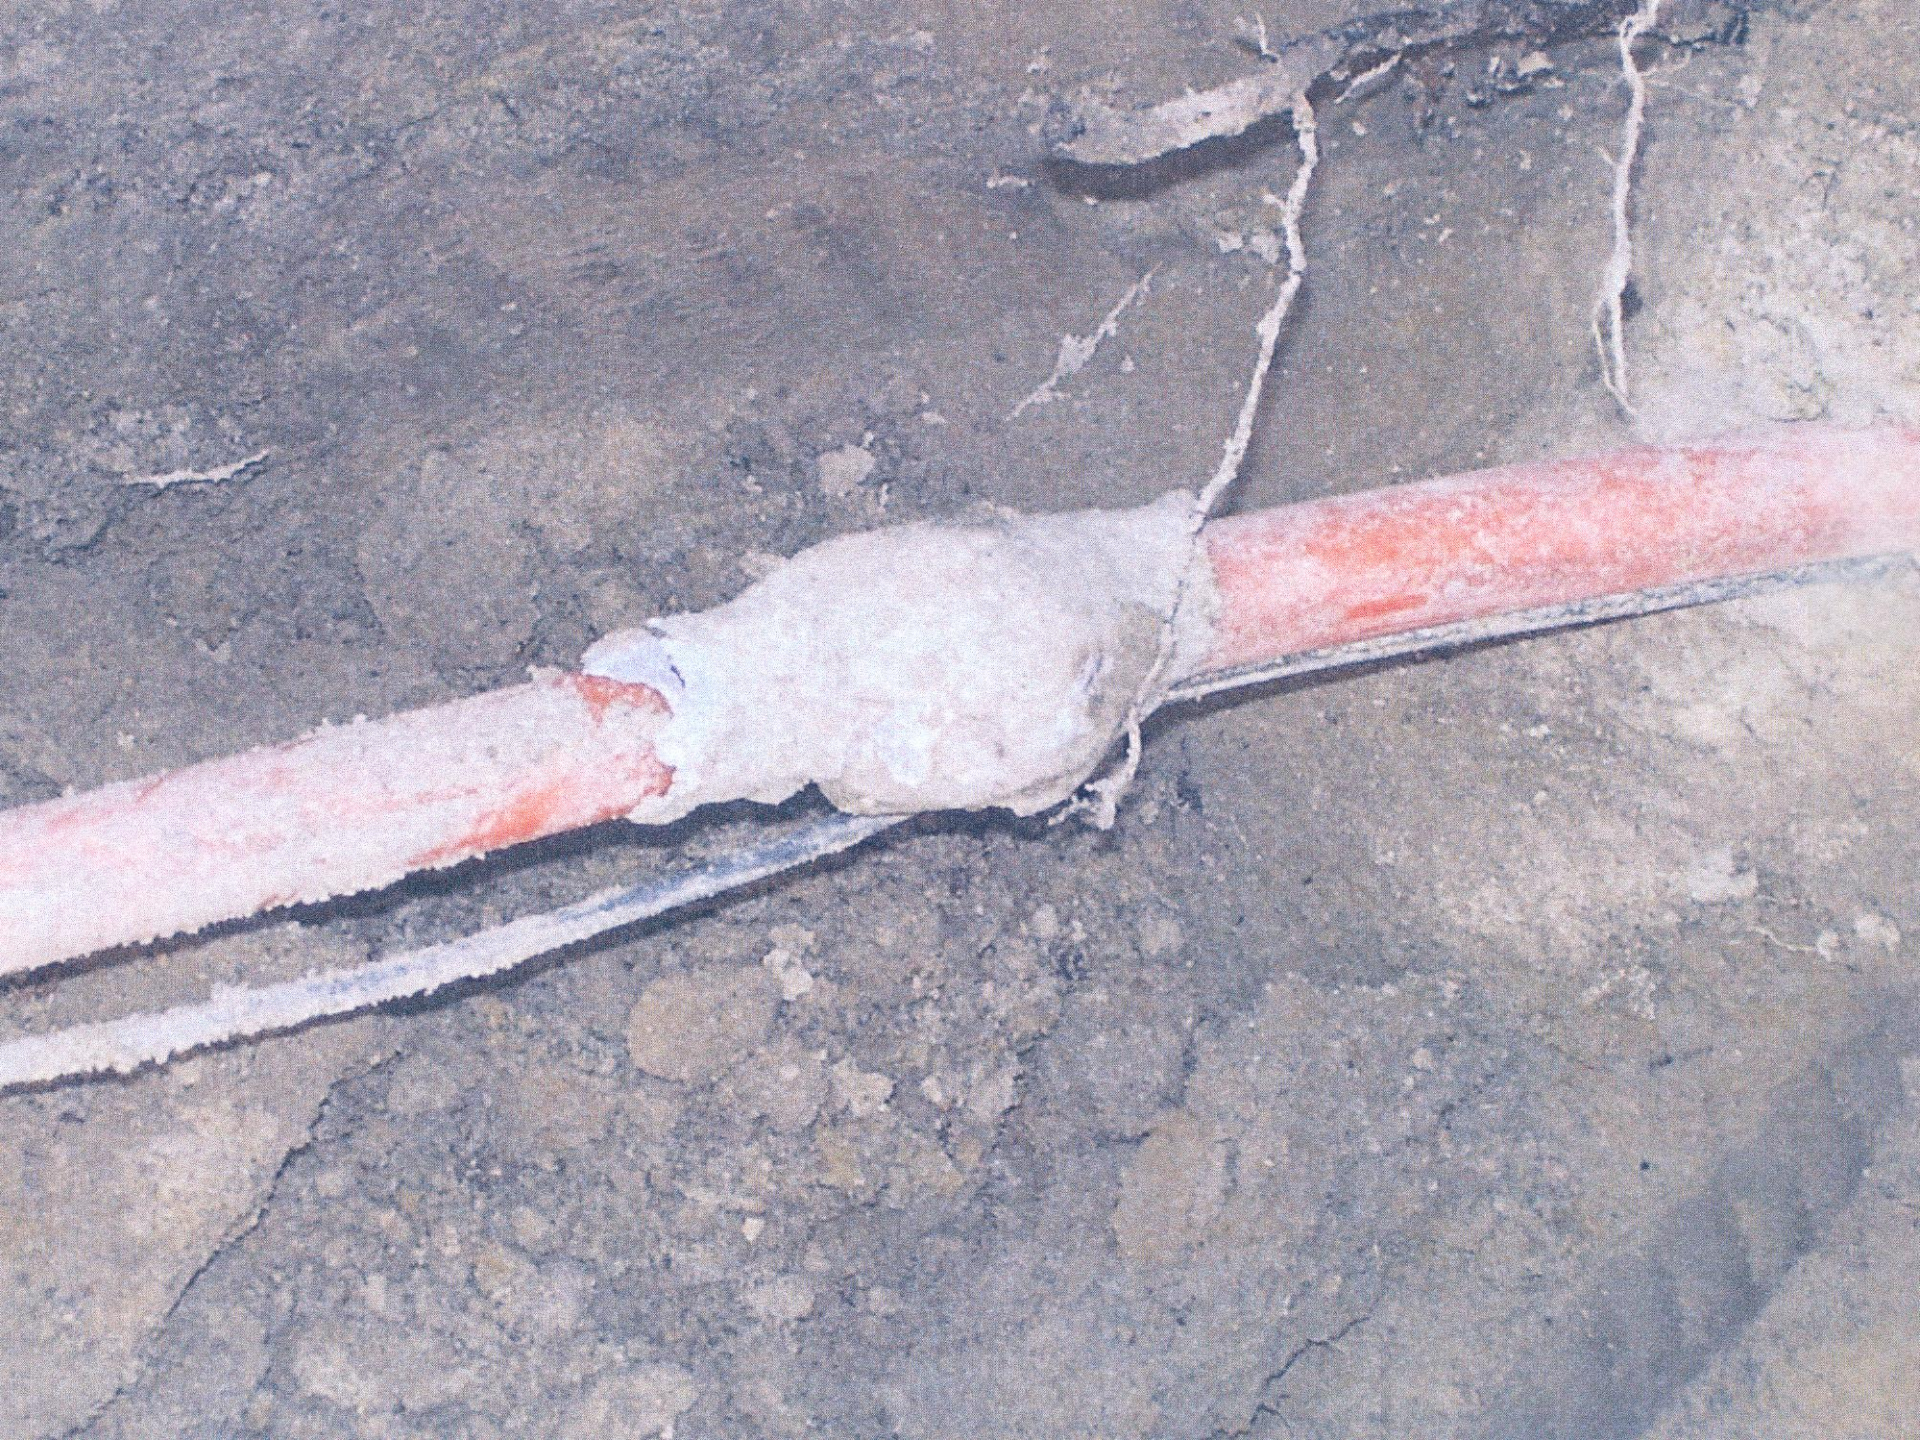
- Gas service was damaged while installing communications
- Damaged gas line was repaired by the excavator with plumber's putty
- Damage was then buried and the operator was not notified
- Gas company was made aware of damage via odor complaints almost 2 months later

- Probable Violations:
  1. 1 – 24A (Exercise due care to protect the utility)
  2. 1 – 24D (Immediately notify the operator of damage)
  3. 1 – 24E (Take steps to safeguard life, health, and property)
- Staff Recommendation:
  - Civil Penalty = \$3,300
- Advisory Committee Recommendation:
  - Civil Penalty = \$5,800

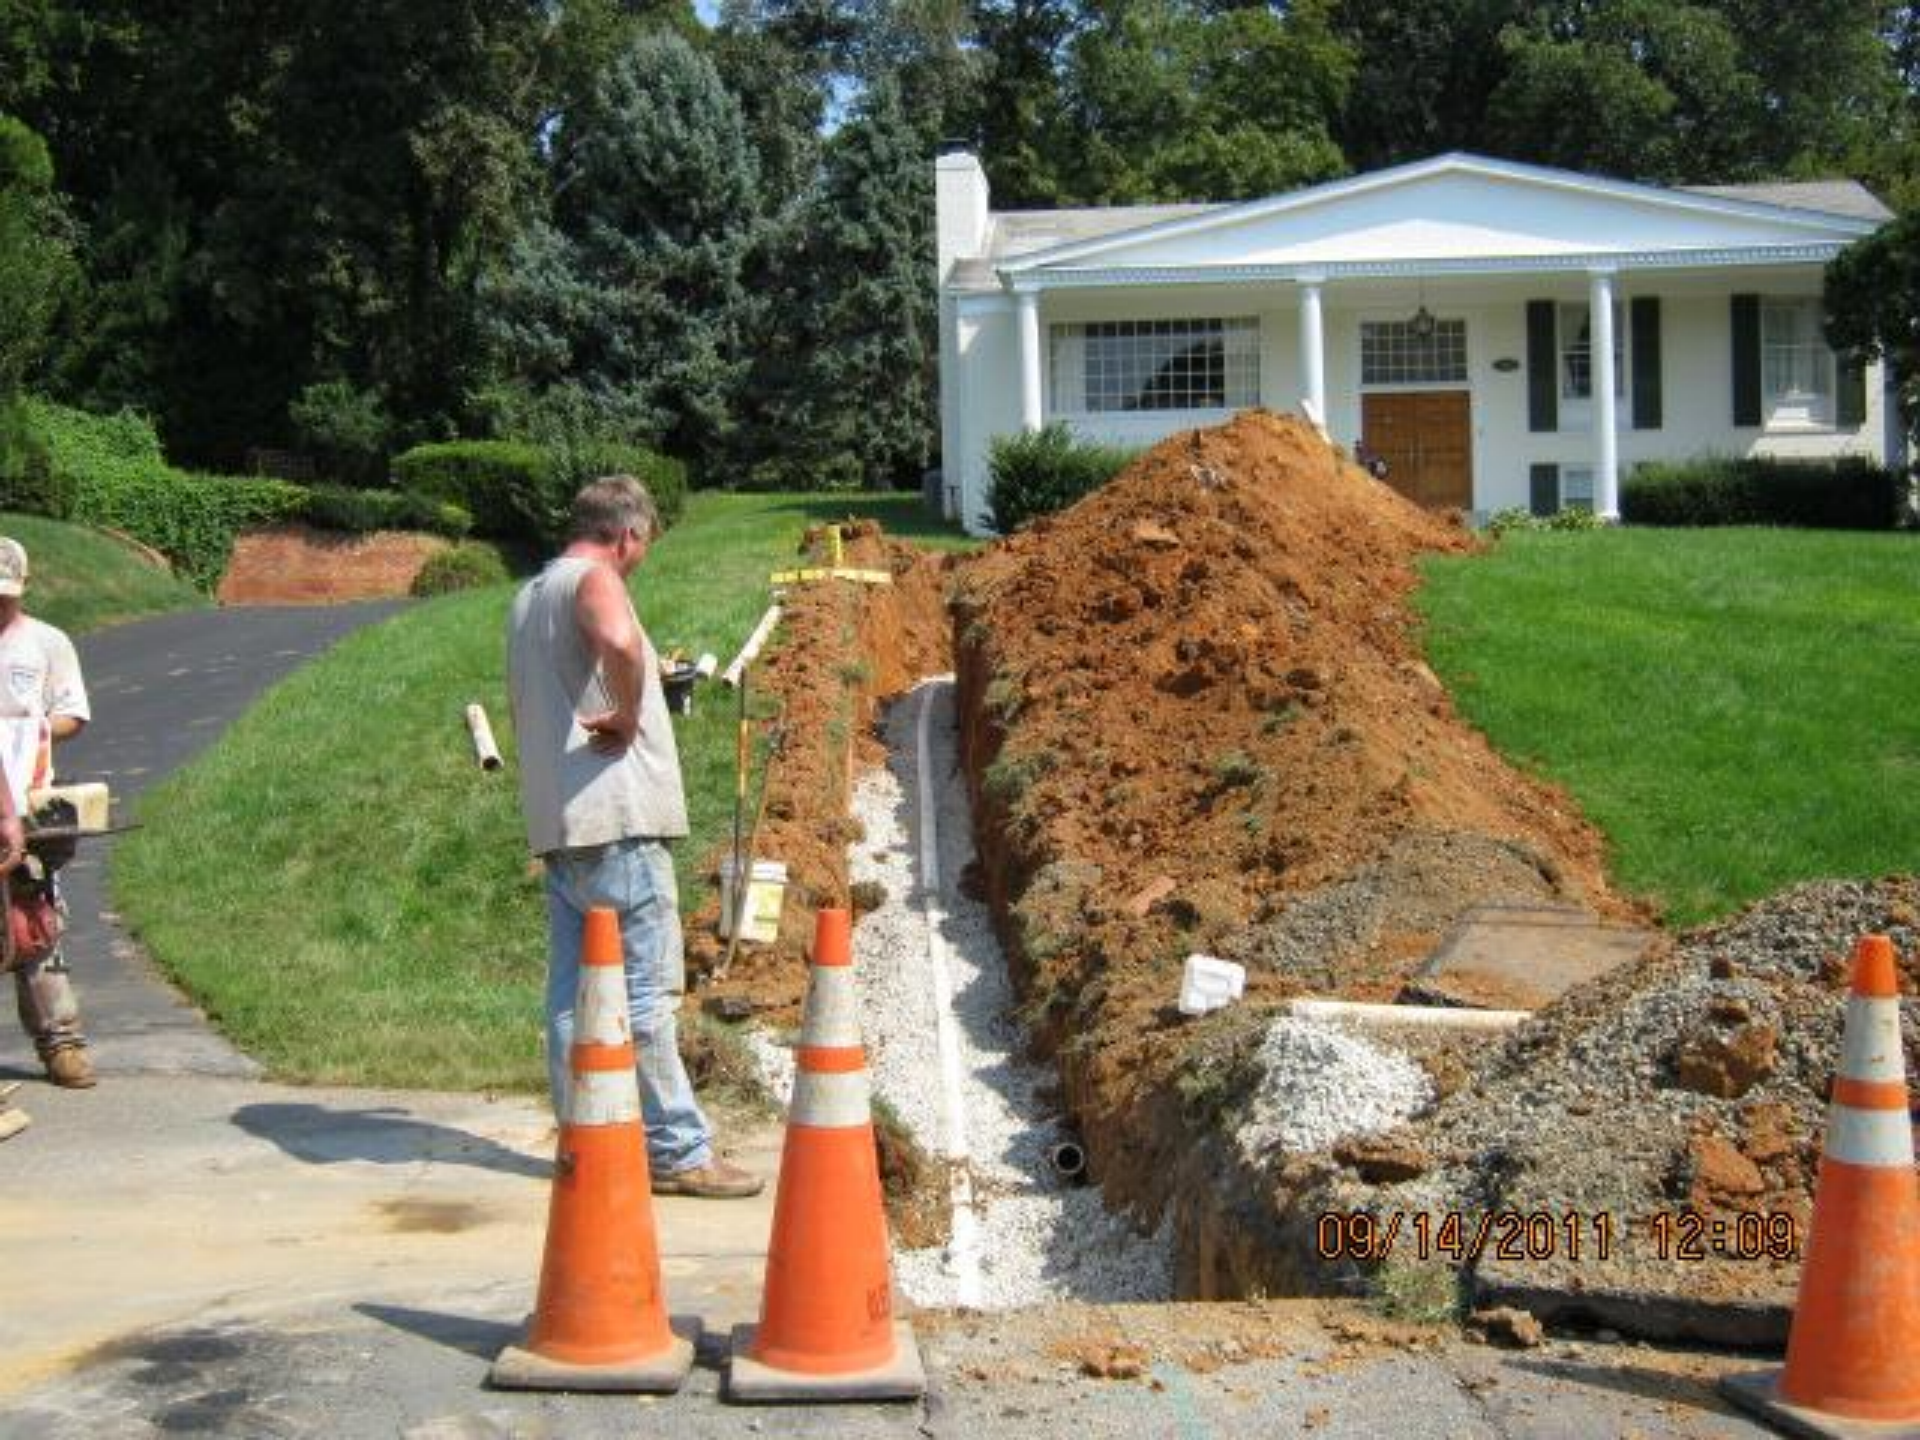
09/14/2011 12:09

- Gas service was damaged with mechanized equipment while doing plumbing and septic work
- No ticket requested prior to the start of the excavation
- Emergency ticket was requested after the excavation began
- Locator arrived to mark the site appx. 40 min after the emergency notice and found the work had been started and the gas service had been damaged
- Excavator capped the damaged line with a lavatory valve
- Locator advised the excavator to call the police and the gas company to report the damage
- Excavator continued to work after the temporary repair was made
- Excavator did not report the damage
- Locator found out almost 2 hrs later that the damage was not reported and notified the operator

- Probable Violations:
  1. 1 – 17A (Notify Miss Utility prior to excavation)
  2. 1 – 24D (Immediately notify the operator of damage)
  3. 1 – 24E (Take steps to safeguard life, health, and property)
  4. 90.3.e. (Wait for the marking of the lines...)
- Civil Penalty - \$5,700
- Training - \$1,750

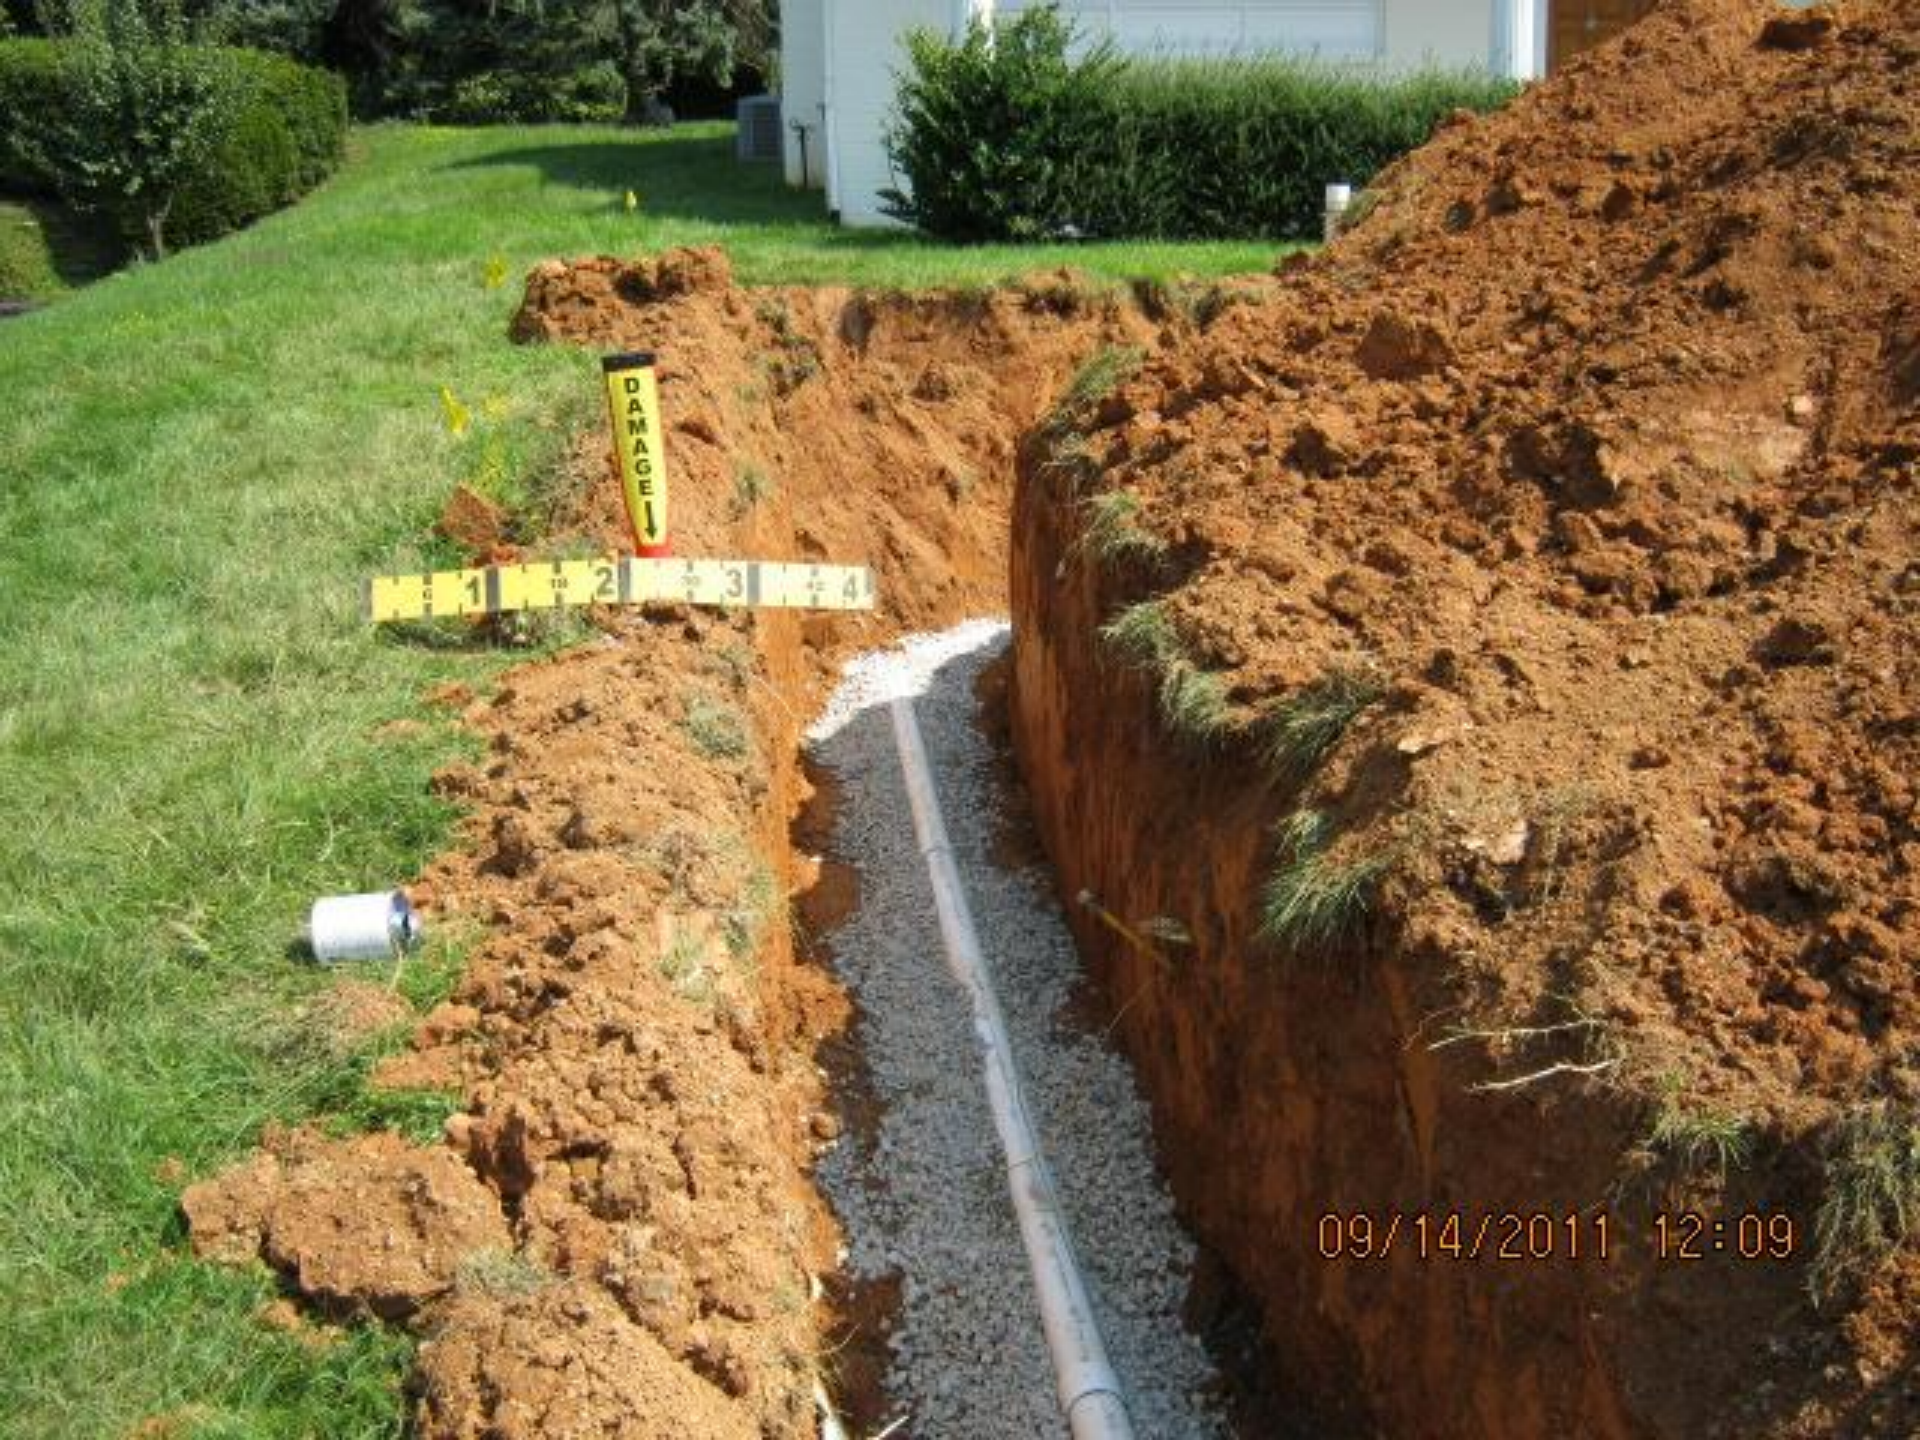
DAMAGE ↓

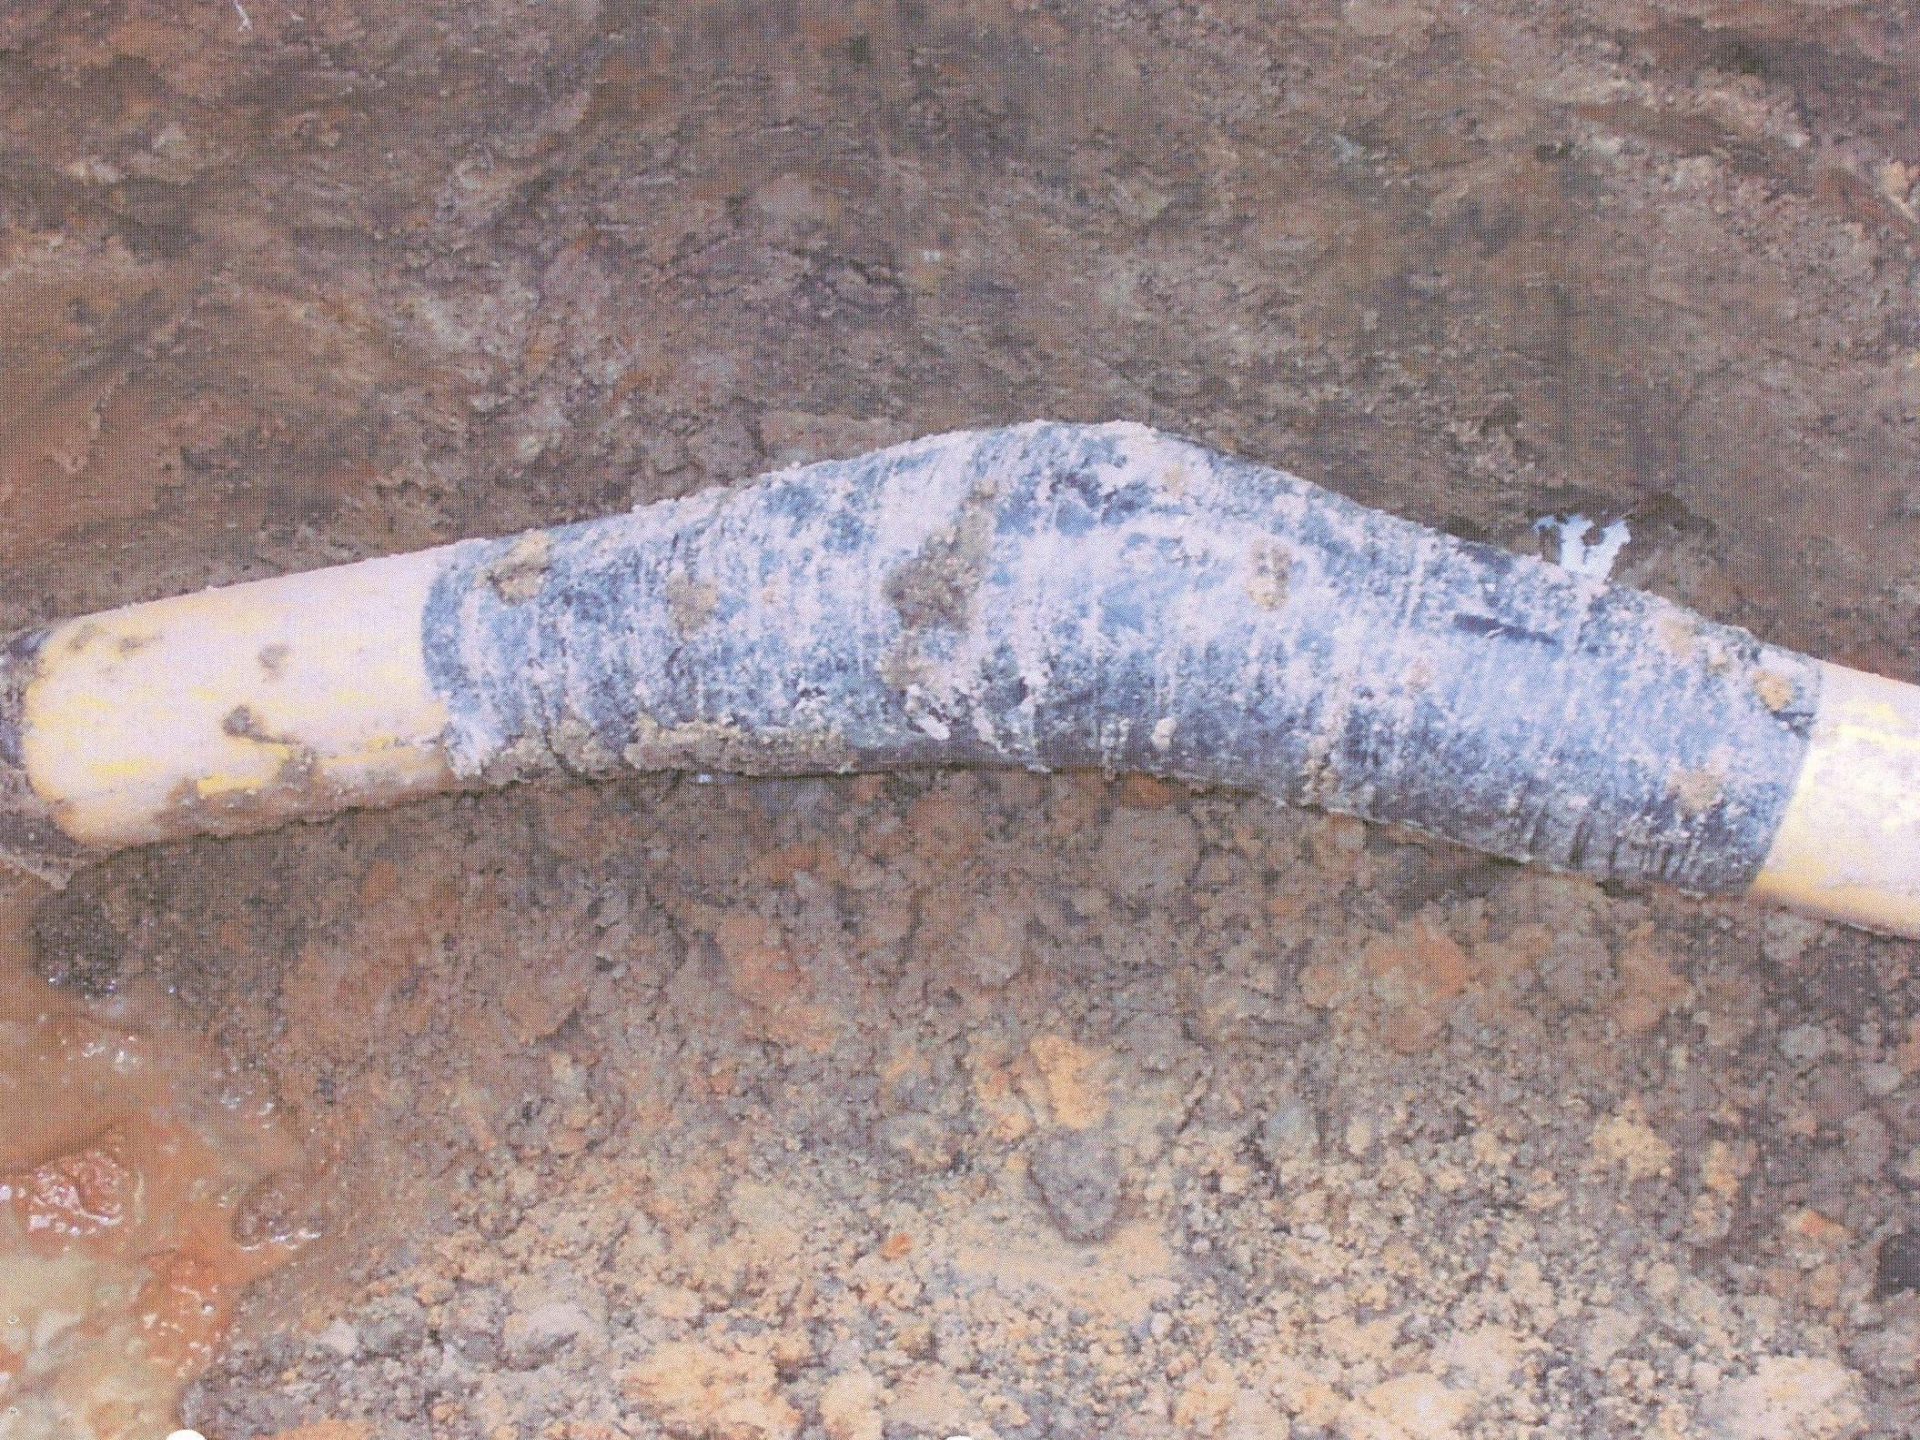
- Excavator had a valid ticket
- Gas main was accurately marked
- Gas main was damaged with mechanical equipment while doing drainage work
- Excavator was using the mechanized equipment within 2 ft of the utility marks
- Excavator did not report the damage
- Gas company was made aware of damage via an odor complaint from the homeowner almost 5 months later
- The foreman instructed his employee to wrap the damaged gas main with electrical tape and to cover it up
- The foreman was a promising employee of the company for over 16 yrs showing great potential, yet was terminated as a result of this incident

- Probable Violations:
  1. 1 – 24A (Exercise due care to protect the utility)
  2. 1 – 140.4 (Maintain a reasonable clearance...)
  3. 1 – 24D (Immediately notify the operator of damage)
- Civil Penalty - \$5,000
