# Reducing Utility Damages -Case Studies-

**Stephen Thomas**  
**Damage Prevention Specialist**  
**Division of Utility and Railroad Safety**  
**State Corporation Commission**

# Case Studies

# **Route 3 Widening Spotsylvania County**

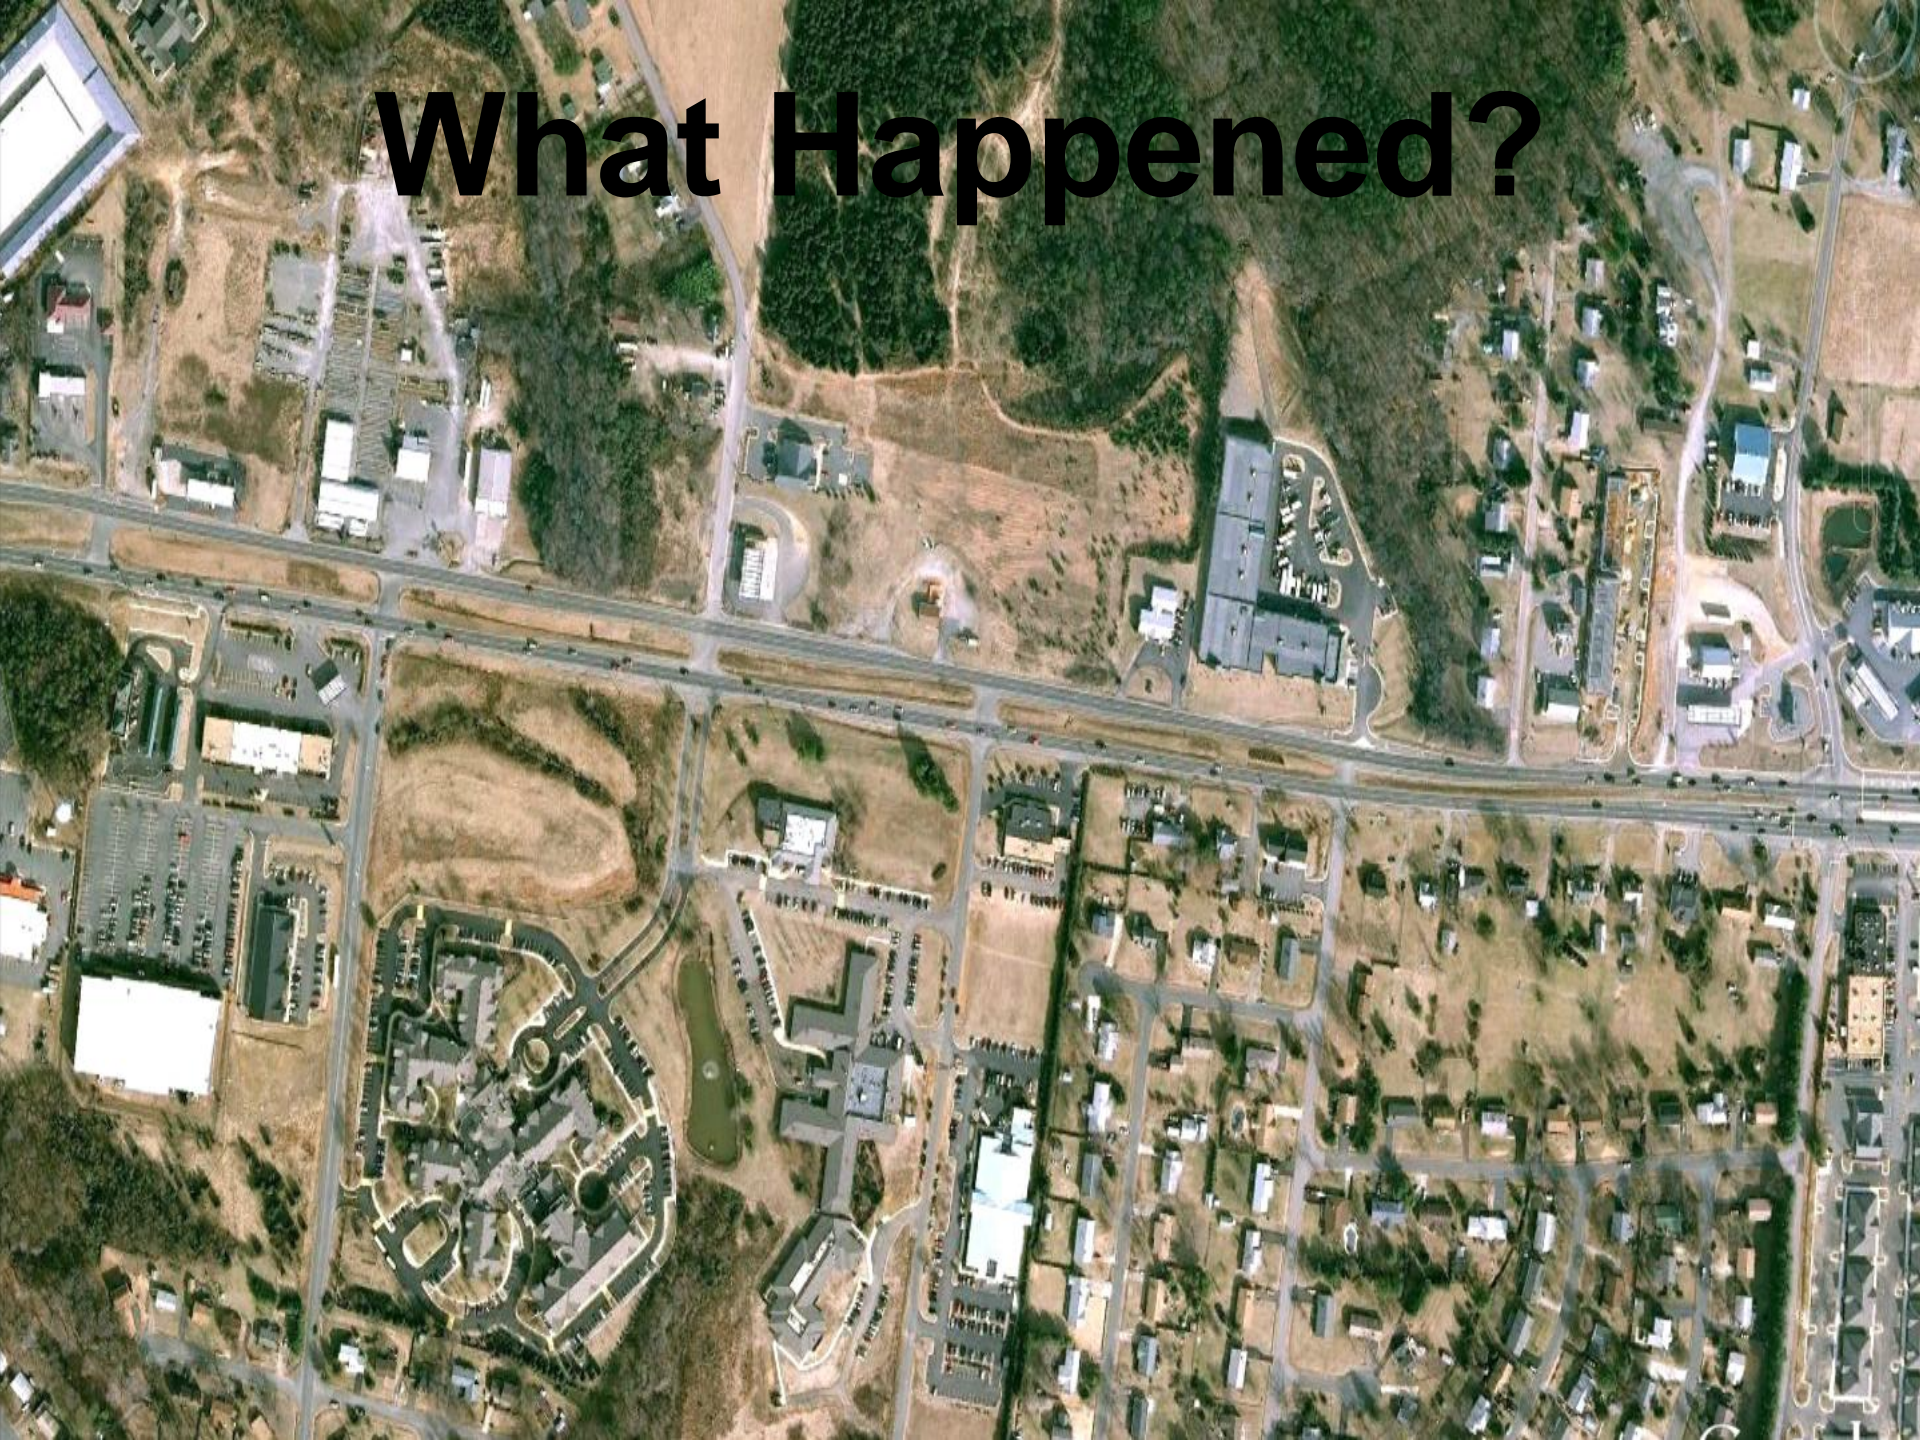
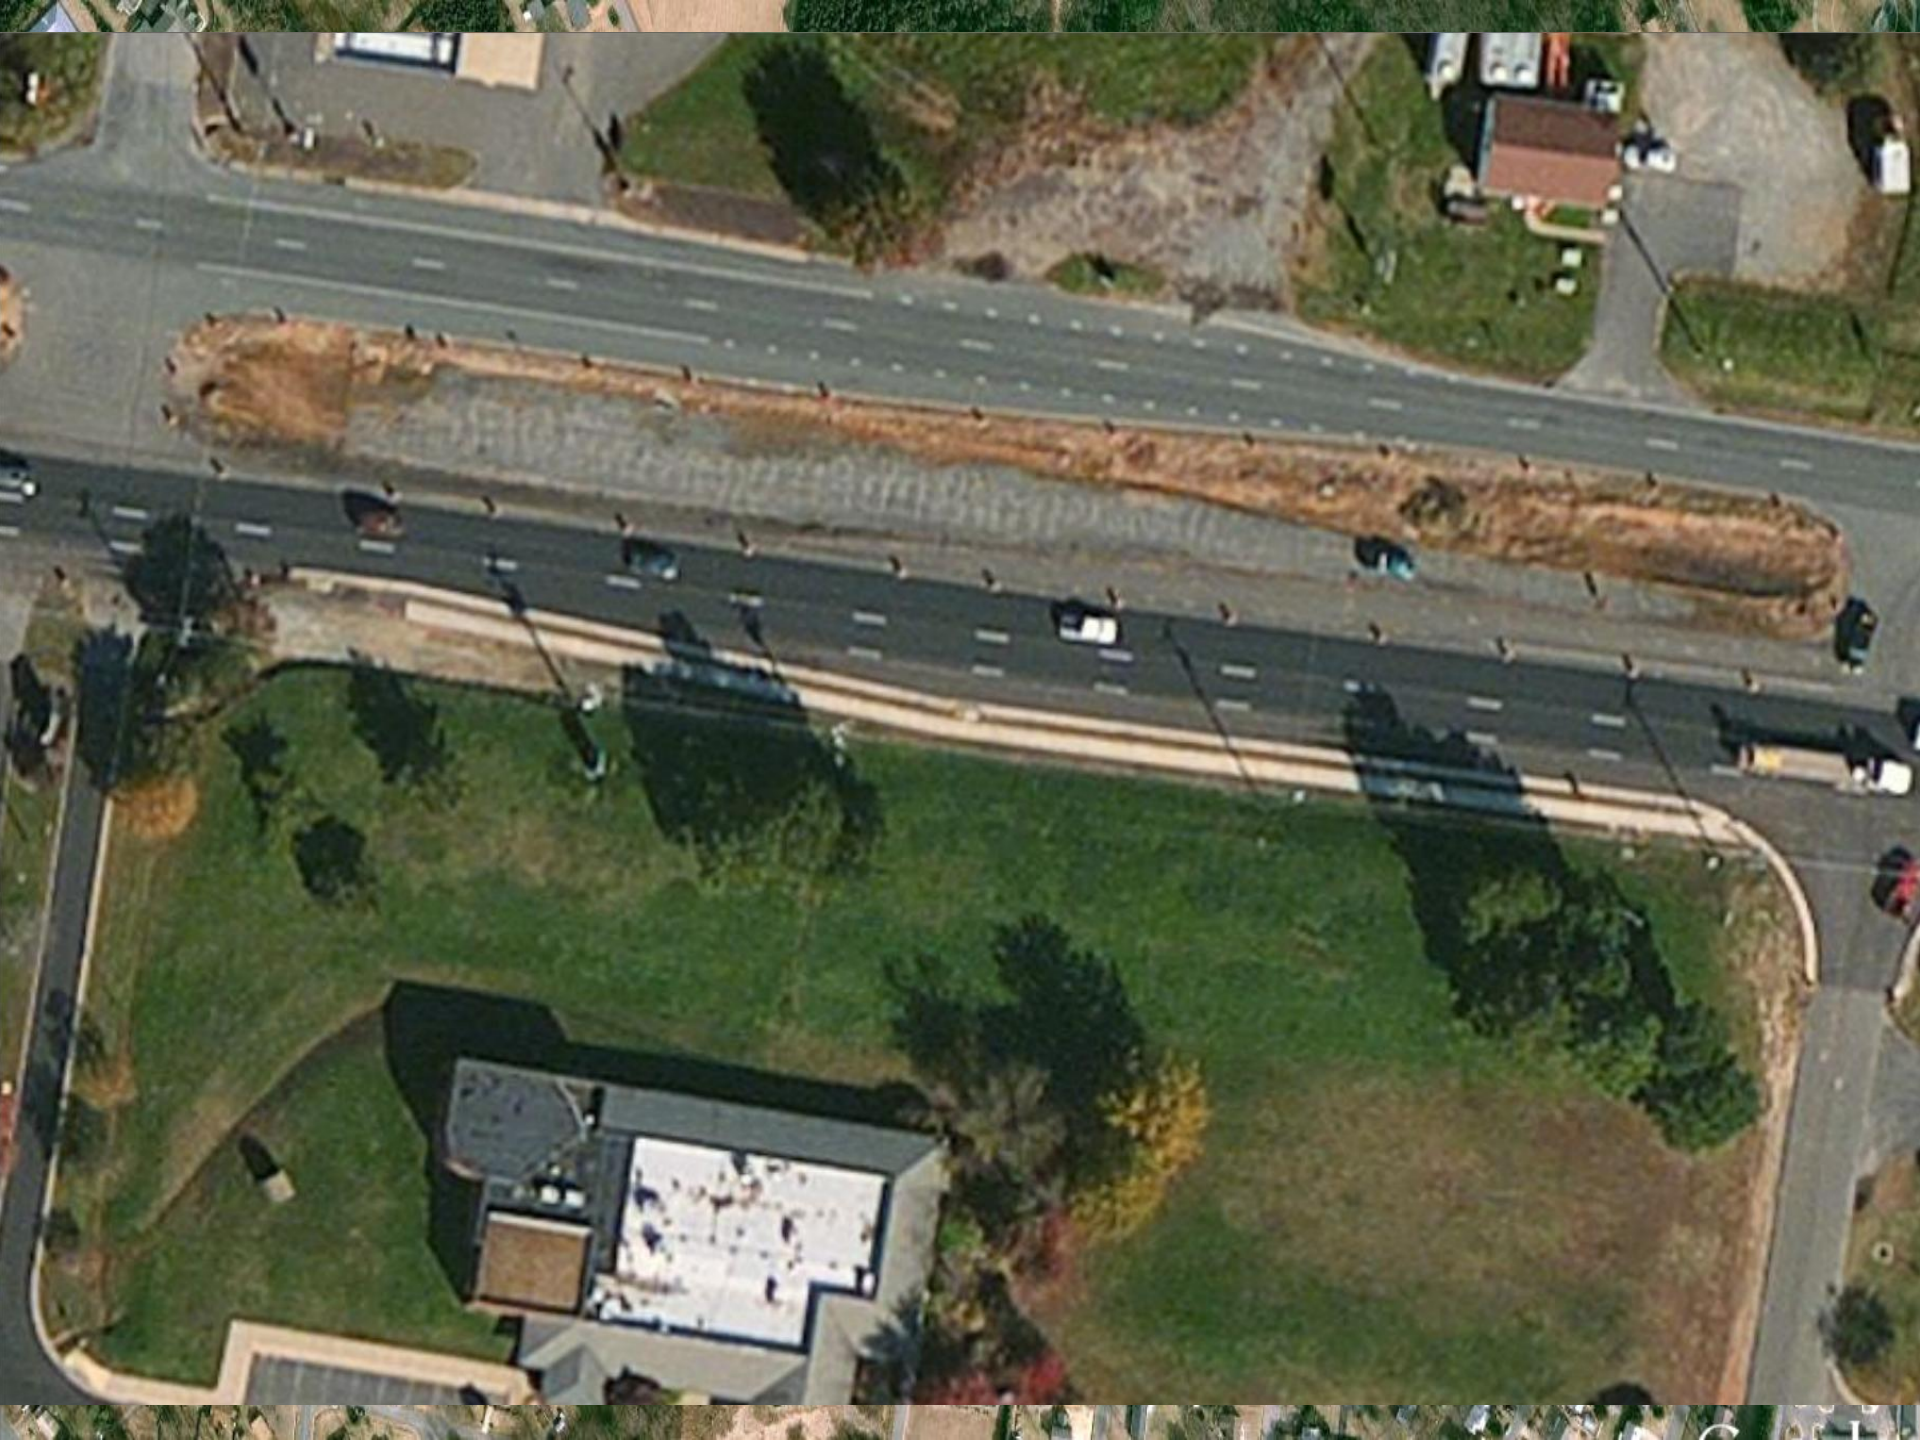
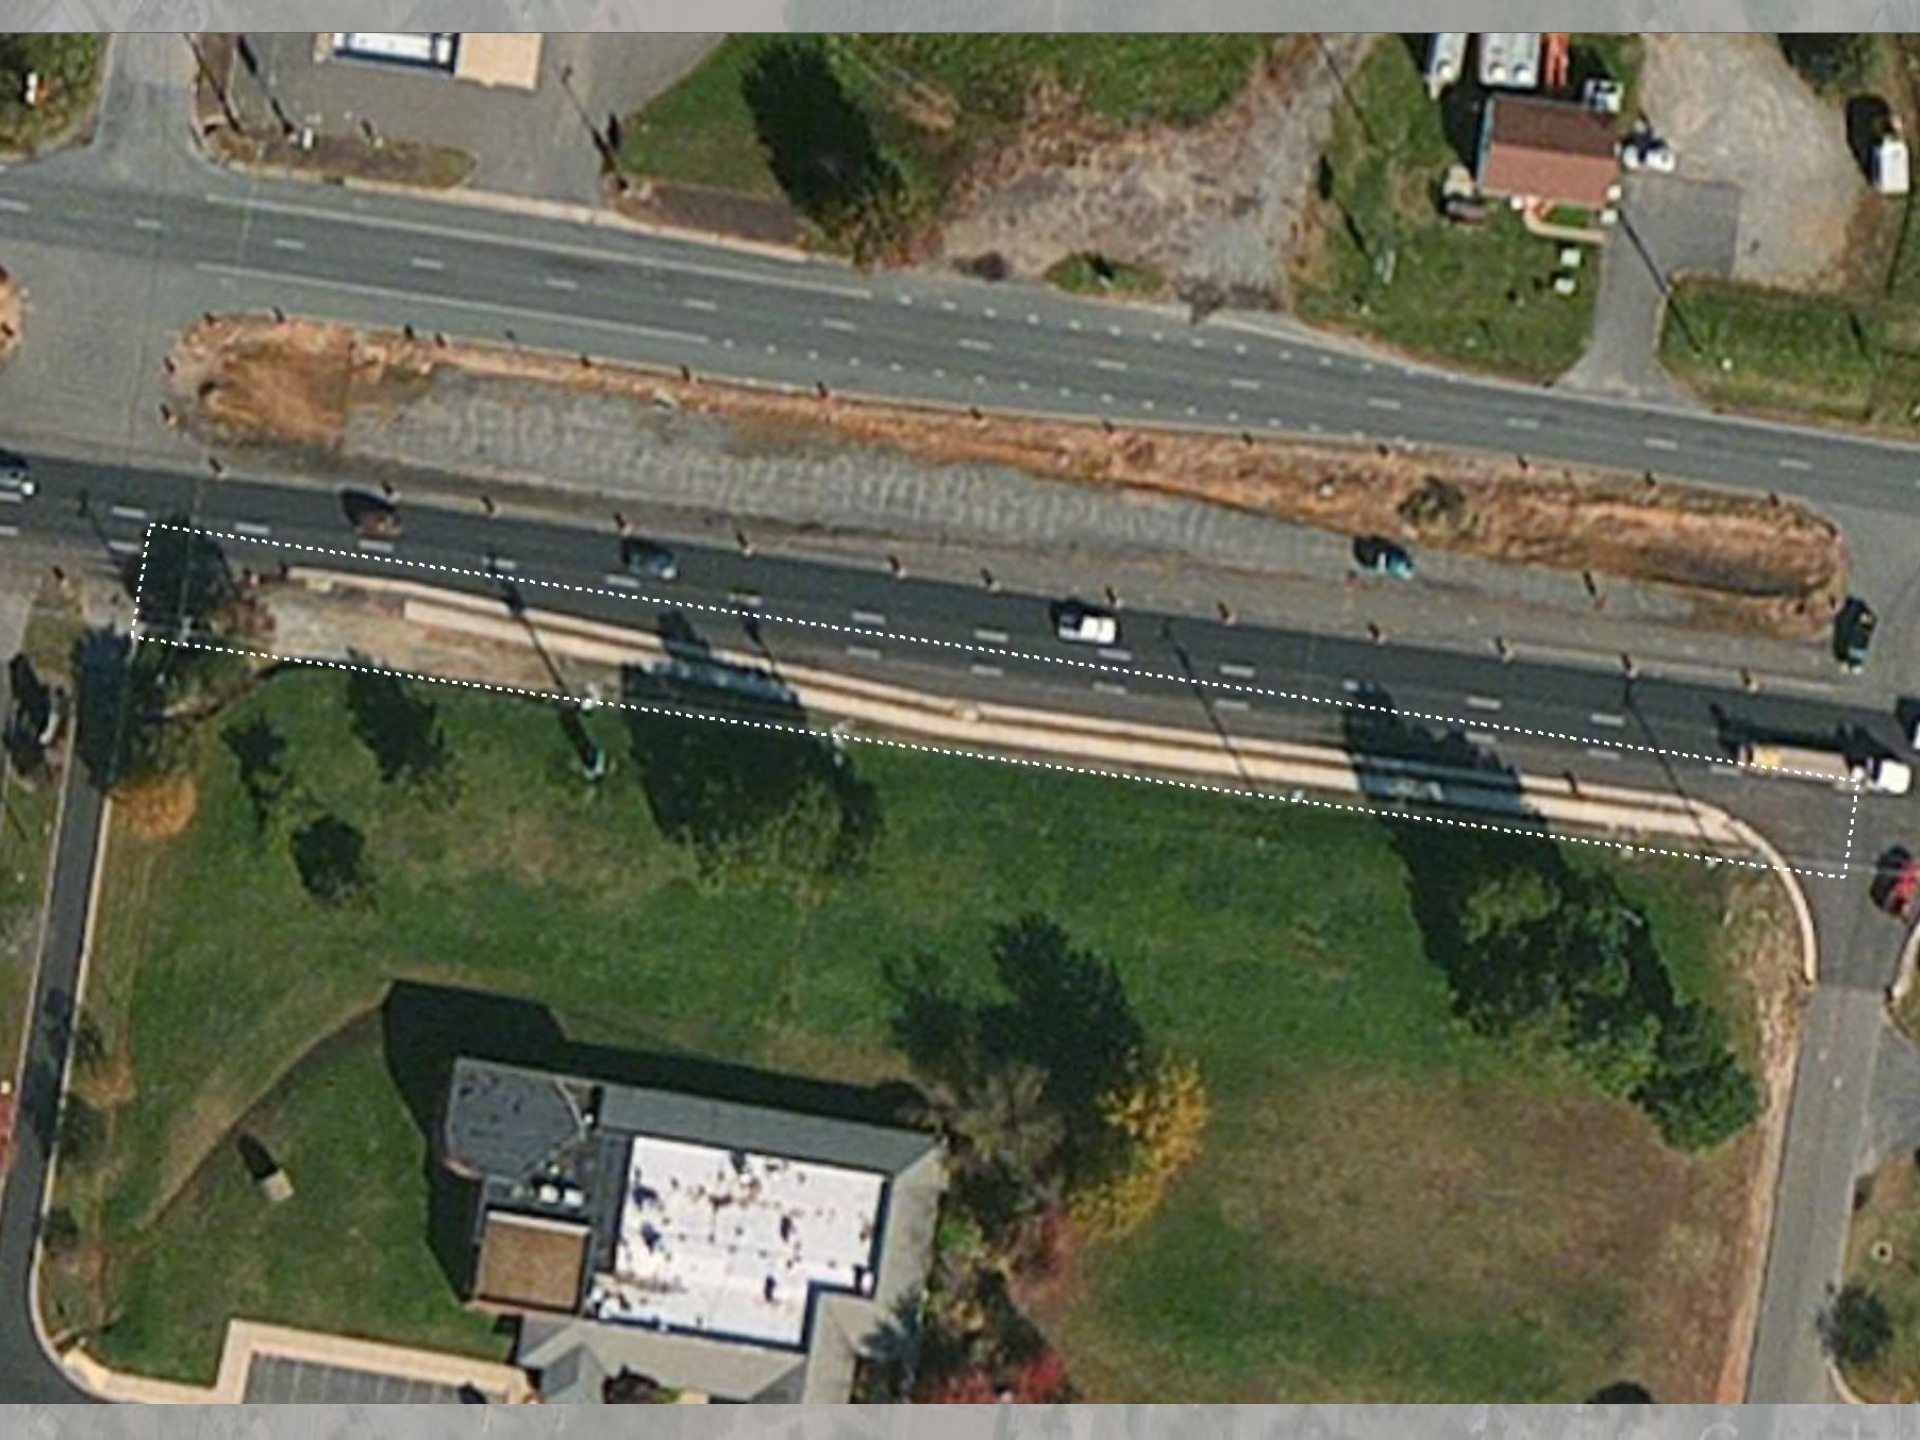
# What Happened?

- May 24, 2011, 44 strand fiber damaged in two different locations causing a major outage
- June 1, 2011, 300 pair cable damaged causing a minor outage
- June 2, 2011, 44 strand fiber damaged causing a major outage, 900 pair pedestal found damaged (STAFF FIRST NOTIFIED)
- June 7, 2011, Advisory Committee addresses situation with General Contractor
- June 9, 2011, 50 pair cable damaged causing a minor outage
- June 14, 2011, 1 inch plastic gas service found damaged
- June 16, 2011, 300 pair cable found damaged
- June 23, 2011, 10 inch steel gas main coating damaged
- July 8, 2011, 44 strand fiber damaged causing a major outage
- July 11, 2011, 44 strand fiber damaged causing a major outage
- July 12, 2011, Locality issues a “stop work” order to the General Contractor, Staff holds an emergency meeting with all stakeholders

- 64 Cancer treatment patients had to reschedule, relocate, or did not receive treatment as a result of the fiber service outages
- Thousands of commercial and private customers lost service on multiple occasions
- Initially road construction was shut down for approximately one month but has since been shut down for an undetermined amount of time
- State political involvement
- High media visibility
- Poor planning causing project delay will ultimately lead to a failure to complete by required deadline

- Acquisition of right of ways took longer than planned and is still not complete
- Design Build Team Senior Representative did not ensure his contractor's were completing their portion of the design process
  - Resulted in utilities in the way of construction
- General Contractor did not have a utility protection plan in place
- Foremen and Supervisors did not understand the requirements of the Underground Utility Damage Prevention Act
  - Resulted in poor decisions
- QA/QC contractors did not fully understand the requirements of the Underground Utility Damage Prevention Act
  - Resulted in no action taken when unsafe acts were being conducted
- QA/QC contractors reported directly to the General Contractor, creating conflict of interest

- Locality issued a “stop work” order which prevented the General Contractor from continuing with planned construction
- Locality required General Contractor to develop a comprehensive utility protection plan
- Required General Contractor to design west bound lanes with utilities relocated prior to being authorized to construct road (phase to be completed this summer)
- SCC required General Contractor to pay a civil penalty as a result of multiple probable violations, and required 100% of the company trained by Staff in English or Spanish
- General Contractor hired sub contractors to assist with utility locating and damage prevention assistance during water main construction

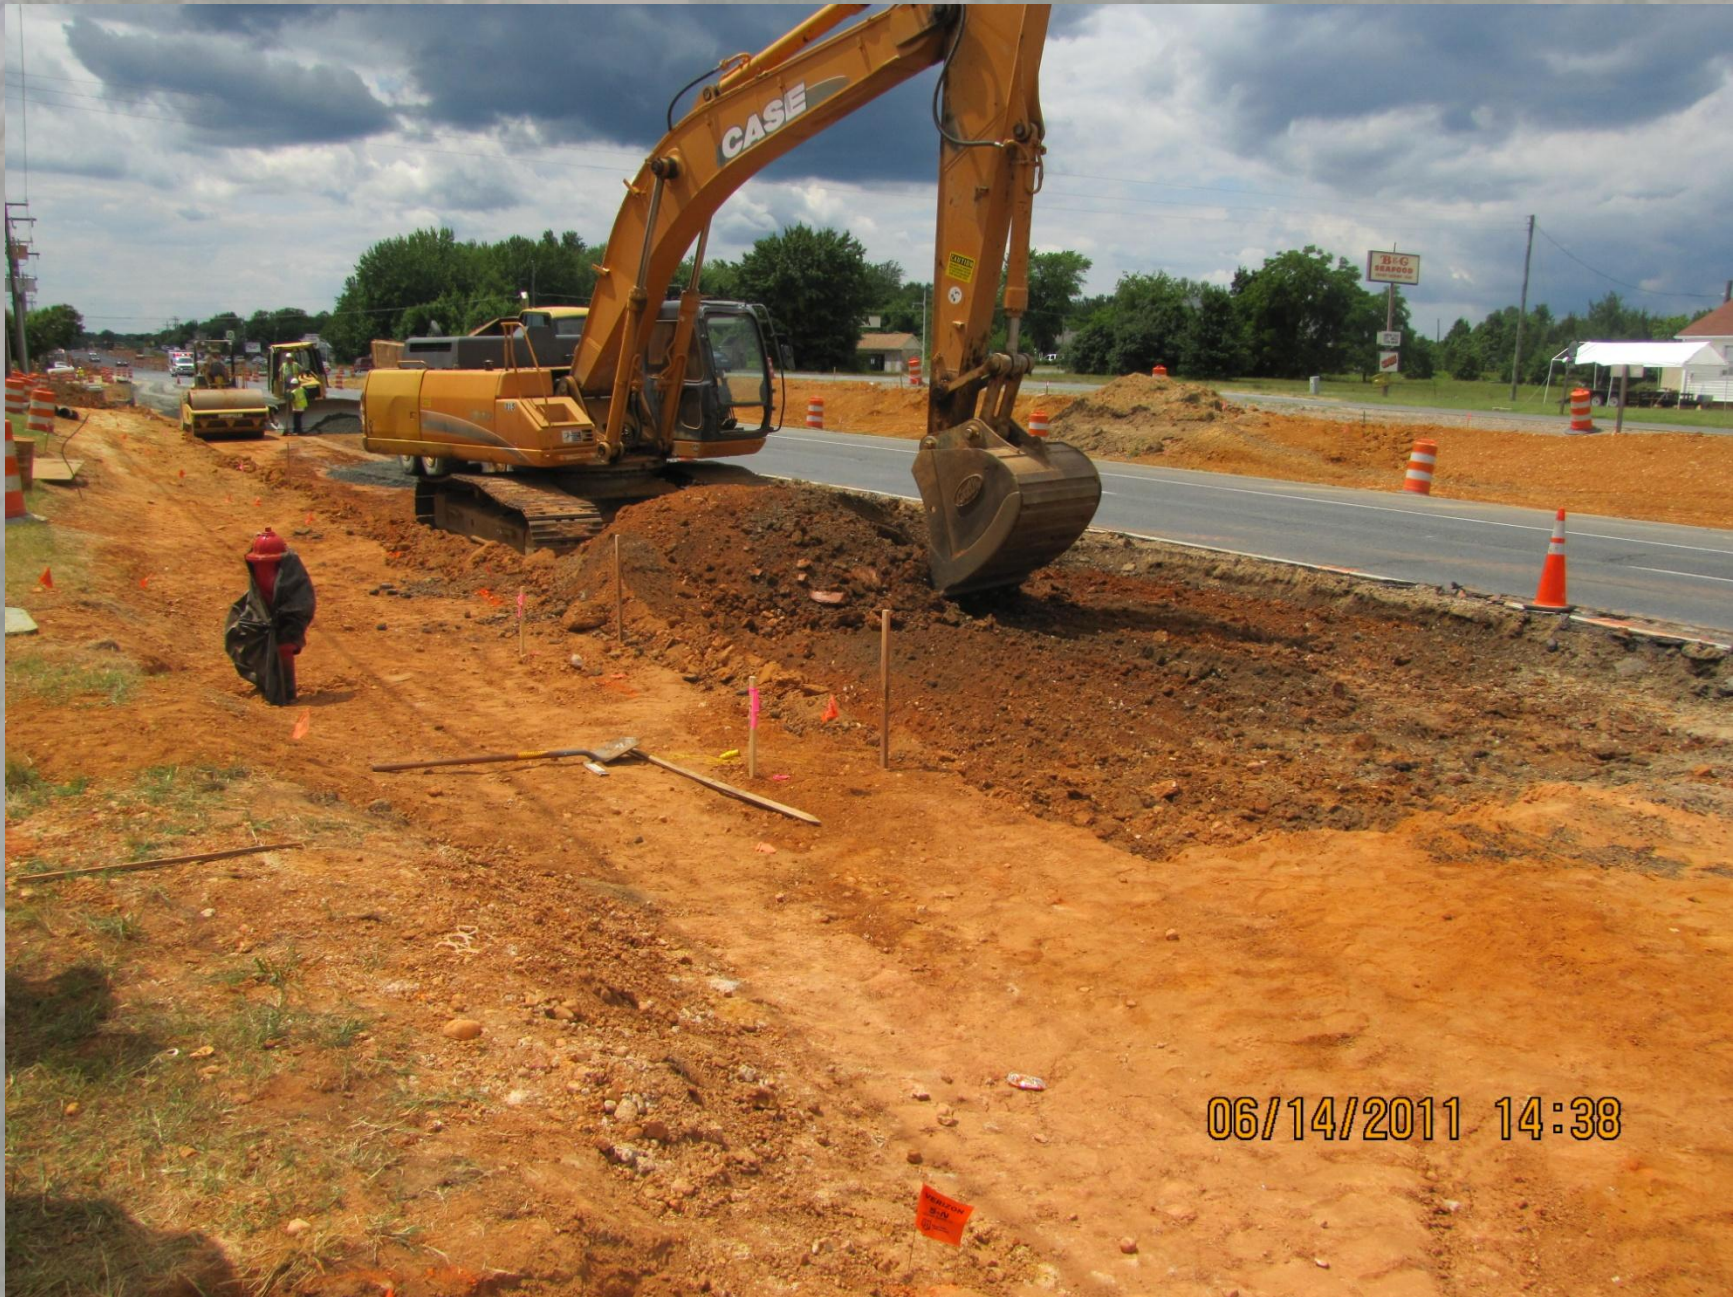
Overall surface area for this location is 3,047 Square Yards

Surface area that falls within a 2 foot buffer is 1,985 Square Yards
